## RECENT RESULT OF THE CAVITY INSPECTION FOR THE SUPERCONDUCTING CAVITIES AT KEK-STF

### Abstract

## KEK-STFにおける超伝導加速空洞の空洞内面検査

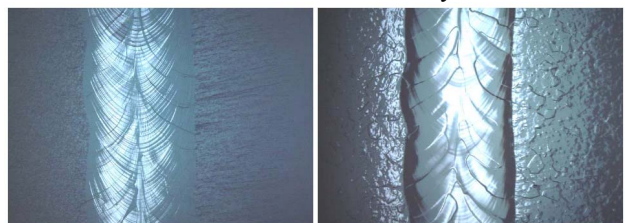
図2：空洞受取後（左）、EP-1後（右）における赤道部の表面状態（MHI-05）

検査箇所を示す。図2にMHI-05の空洞受取後とEP-1後の赤道部における溶接シームの様子を示す。通常行っている観察位置は、赤道部およびアイリス部の電子ビーム溶接部すべてと赤道部の開先から±15mmの領域である。

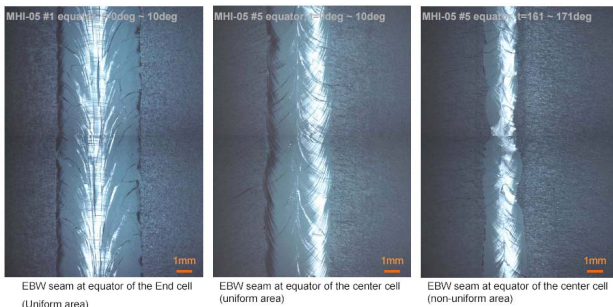
図3にMHI-05およびMHI-06、図4にMHI-07からMHI-09のエンドセルおよびセンターセルの赤道部における電子ビーム溶接シームの代表例を示す（空洞受取直後の状態）。ここで、MHI-05およびMHI-06は2007年度に製作され、一方、MHI-07、MHI-08およびMHI-09は2008年度に製作されたものであり、各ロッドの品質に差は見られなかった。

MHI-05およびMHI-06では、エンドセル（1-cellと9-cell）の溶接シームは赤道部全周を通して安定であった（幅、高さなど）。一方、センターセル（2-cell~8-cell）では、赤道部一周の間に安定と不安定な領域が混在していた（溶接シームの幅が2~5mmとばらつきが大きい）。この不安定な溶接シームができる原因として、トリム加工における開先部の厚みに対する工作精度（0.1mm程度）が考えられ、MHI-07からMHI-09では、電子ビーム溶接の条件を最適化し、赤道部全周を通して安定な溶接シームを得ることができた[3]。これら溶接シームの違いが空洞性能に与える影響についても調査の対象となる。

図3：MHI-05の赤道部の様子

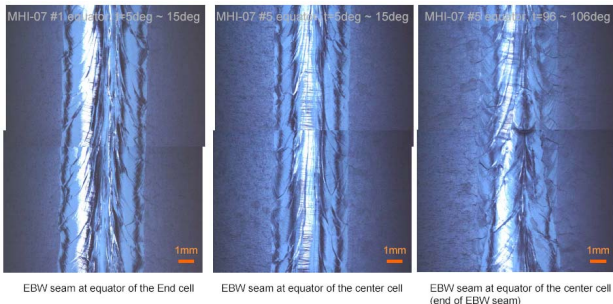
図4：MHI-07の赤道部の様子

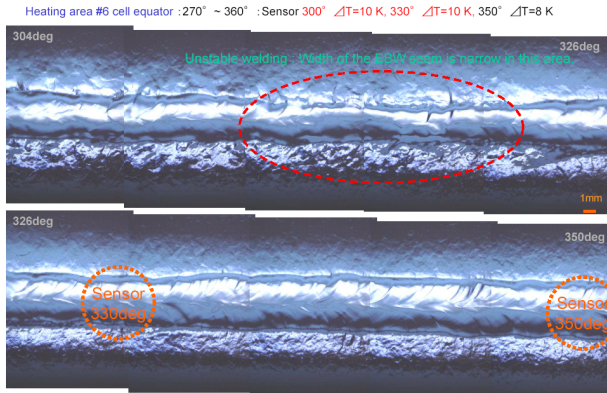
MHI-05（1<sup>st</sup>、2<sup>nd</sup>）およびMHI-06（1<sup>st</sup>、4<sup>th</sup>）では、パスバンドモードの測定において、High fieldで発熱が観測された位置近傍に電子ビーム溶接シームが不安定な箇所が観測された（他にも不安定な箇所が存在するが、発熱が観測されない箇所もあった）。図5はMHI-05で観測された溶接シームが不安定な箇所の代表例である。図中のオレンジの円は温度センサーの位置を示している。図6に図5で示した箇所の空洞受取後の様子を示す。MHI-05（2<sup>nd</sup>）、およびMHI-06（4<sup>th</sup>）のπモードでは、約20MV/mでクエンチが起こっているが、この発熱箇所周辺に対して異常は観測されなかった。

29.2 @ 7/9 Quench	#5 cell equator, t=120~180deg.	Unstable: Width of the EBW seam is narrow. No defect in outside weld area.
		32.9 @ 6/9 Quench	#6 cell equator, t=270~360deg.	Unstable: Width of the EBW seam is narrow. No defect in outside weld area.
MHI-06	1 <sup>st</sup>	25.7 @ Pi-mode Field emission?	#7 cell equator, t=150~180deg.	Unstable: Width of the EBW seam is narrow. No defect in outside weld area.

図5：MHI-05 (2<sup>nd</sup>) で観測された発熱箇所の内面状態 (縦測定後：#6-cell 赤道部、角度304~350°)  
#6 equator, 279 ~ 325 degree. Condition : As received.

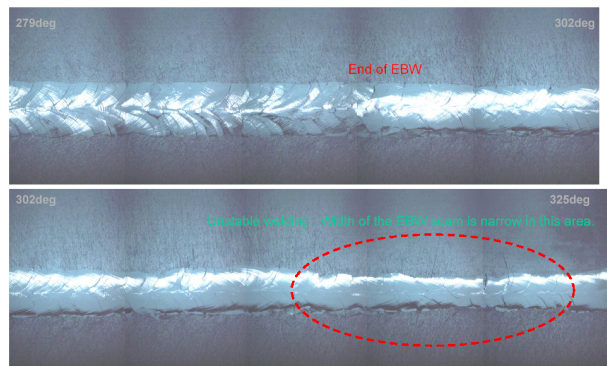
図6：MHI-05で観測された発熱箇所の内面状態 (受け取り直後：#6-cell 赤道部、角度279~325°)

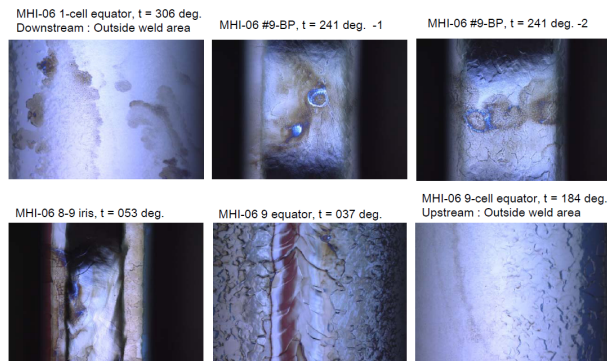
一方、STF電解研磨処理施設ではEP液中のニオブの溶け込み量が増加したため、2009年5月にEP液を新液に交換した。EP液交換後、初めに処理を行った2空洞（1回目：EP-2 MHI-06 5<sup>th</sup>、2回目：EP-2 MHI-07 1<sup>st</sup>）はField emissionで空洞性能が制限された。

39.9 @ 3/9 Quench	#5 cell equator, t=200~300deg.	Unstable: Width of the EBW seam is narrow. No defect in outside weld area.
5 <sup>th</sup>	22.1 @ Pi-mode Field emission	No detection due to RF cable trouble	-----	
A lot of stains found after V.T. by cavity inspection. The stains were observed all over of inside of cavity				
Note: EP acid changed before EP-2 process. EP-2 process was First time after changing EP acid (New one) at KEK-STF.

図7：新液でEP-2を行った際、空洞内部に発生したシミの様子 (例：MHI-06 5<sup>th</sup>の縦測定後の様子)

図7はEP液交換後、初めて処理をしたMHI-06 (5<sup>th</sup>) の内面状態であり、空洞内面全域に亘ってシミ状の異常が多数観測された。また、2回目に処理をしたMHI-07 (1<sup>st</sup>) についても同様に空洞内面全域に亘って同様の異常が多数観測された。また、縦測定時に観測された発熱位置に対しては、近傍にシミ状の異常が観測されるケースが多かった。3回目に処理を行ったMHI-08 (1<sup>st</sup>) では、シミ状の異常の総量は格段に減少し、程度の軽いものが両ビームパイプ、1-cell~3-cellおよび7-cell~9-cellに観測された。空洞性能は2-cell赤道部におけるクエンチで制限さ

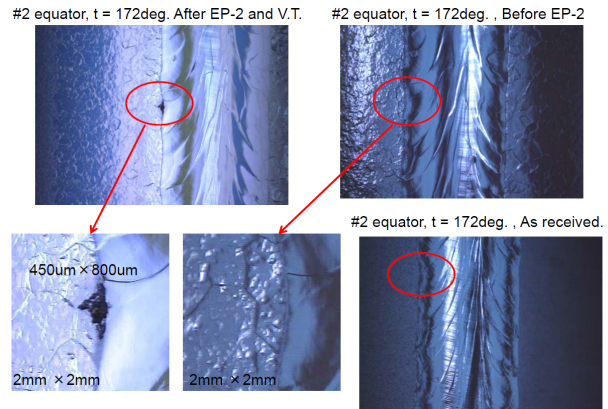
26.7 @ 4/9 Quench	#4 cell equator, t=30~120deg.	Stain	
A lot of stains found after V.T. by cavity inspection. The stains were observed all over of inside of cavity				
Note: EP-2 process was Second time after changing EP acid (New one) at KEK-STF.				
MHI-08	1 <sup>st</sup>	16.0 @ Pi-mode Quench	#2 cell equator, t=140~200deg.	Heavy Stain: Contamination? #2 cell equator area, t=172 deg. Size = 450*900μm

れ、電界強度は16MV/mであった。図8にMHI-08 (1<sup>st</sup>) の2-cellで観測された発熱箇所中心のEP-2処理前後における内面状態を示す。縦測定後観測した結果、2-cell赤道部の $t=172^\circ$  の位置に粒界に沿った形で黒く変質している異常が見つかった (サイズ： $450\mu\text{m} \times 800\mu\text{m}$ )。EP-2前の様子では、このような異常は観測されていないため、EP-2以降の工程で発生したものであると考えられる。また、今回観測されたシミ状の異常などの詳細な成分分析は、現在、KEKの加藤、西脇らの表面研究チームが調査中である。

図8：MHI-08 (1<sup>st</sup>) で観測された発熱箇所の内面状態 (EP-2前後での比較：2-cell、角度172°)
