# High power continuous wave test of RF couplers for the RFQ of the Linear IFMIF Prototype Accelerator.

DE FRANCO Andrea for the LIPAc team

第20回日本加速器学会年会 - 29<sup>th</sup> August – 1<sup>st</sup> September 2023

Linear IFMIF Prototype Accelerator (LIPAc)

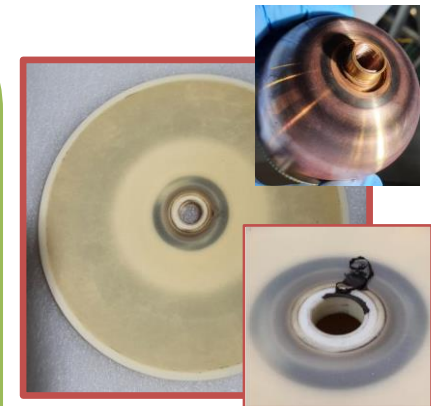
O-ring couplers damaged during RF conditioning at high duty cycle.

Alumina window after O-ring melt. Visible O-ring debris. Cu black deposits at high filed region on ceramic and anchor.

Improved heat extraction design and re-installed in RFQ.

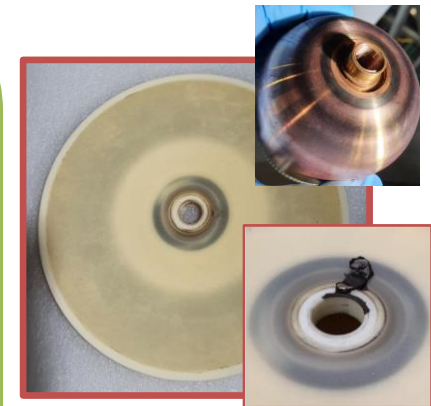
O-ring couplers damaged during RF conditioning at high duty cycle.

Alumina window after O-ring melt. Visible O-ring debris. Cu black deposits at high field region on ceramic and anchor.

Improved heat extraction design and re-installed in RFQ.

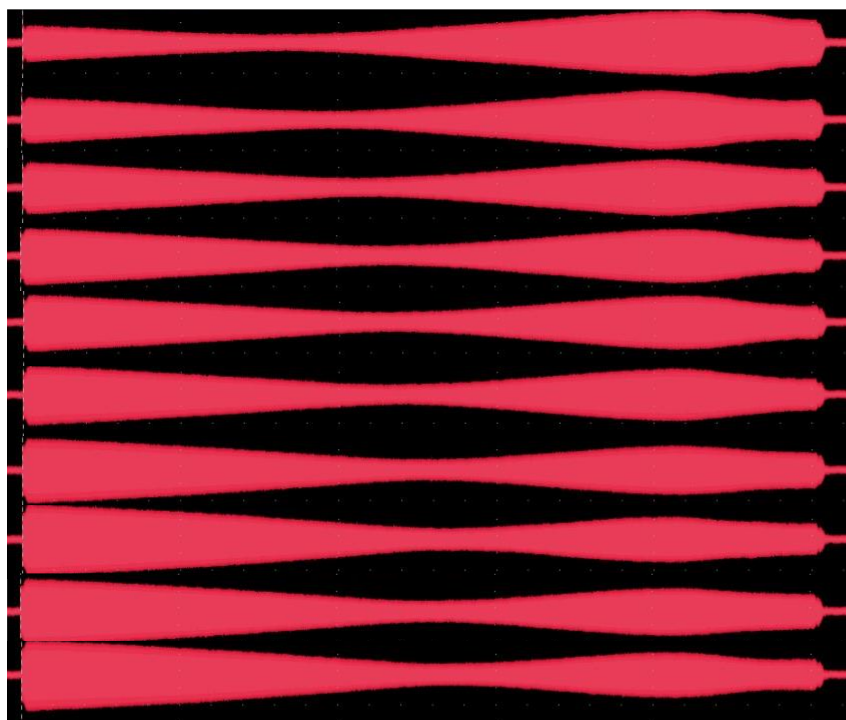
1. Increase FWD to 220 kW, 10  $\mu$ s pulse width, 1 s rep. period
  2. Decrease rep. period to 10ms
  3. Elongate pulse width
- REV pulse shape + vacuum H<sub>2</sub>O splits in O and H

→ Multipacting/Plasma?

Cavity frequency  
detuned  $\sim 30$  kHz

Rev pulse shape for different resonant frequency adjusted with tuner.

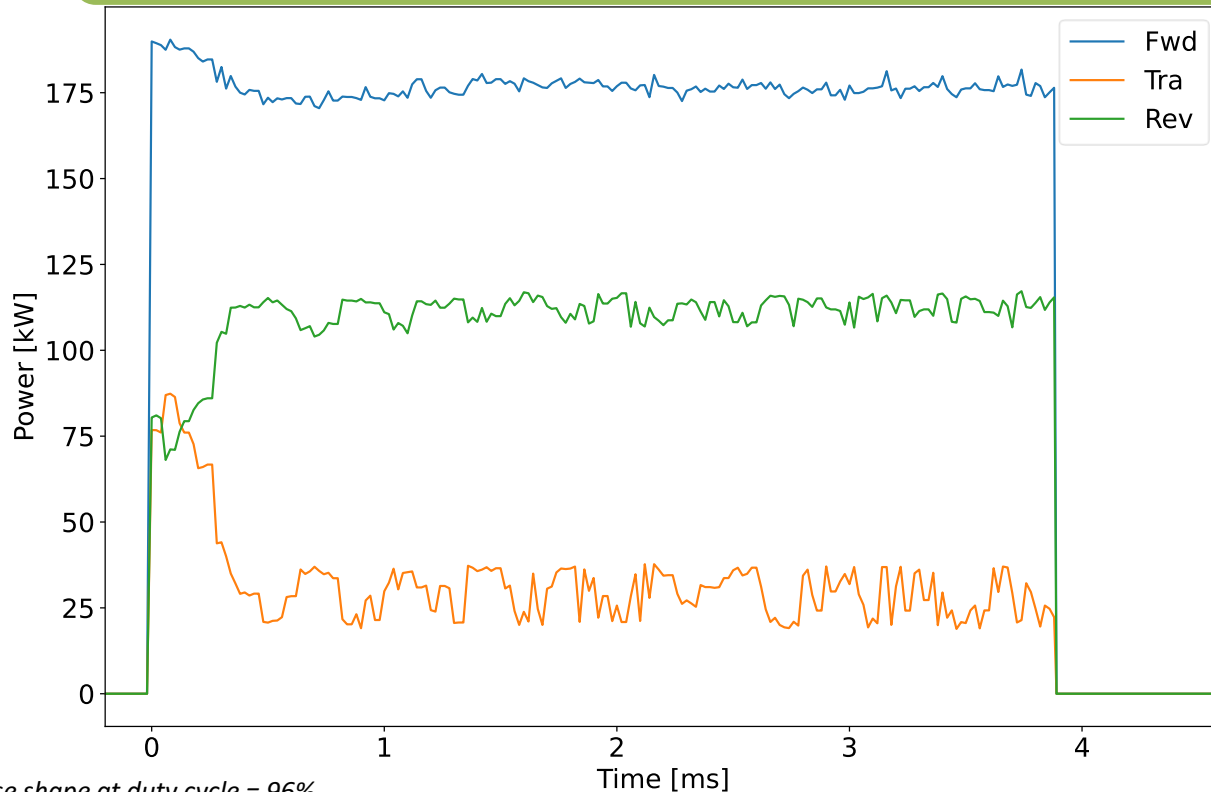
Pulse shape at duty cycle = 96%

MP in cavity, not in CPL1 because:

- CPL1 T increase minimum
- Cavity tuning changes pulse shape
- No light observed at CPL1 view port
- High SEY of Al
- Cavity visual inspection after test

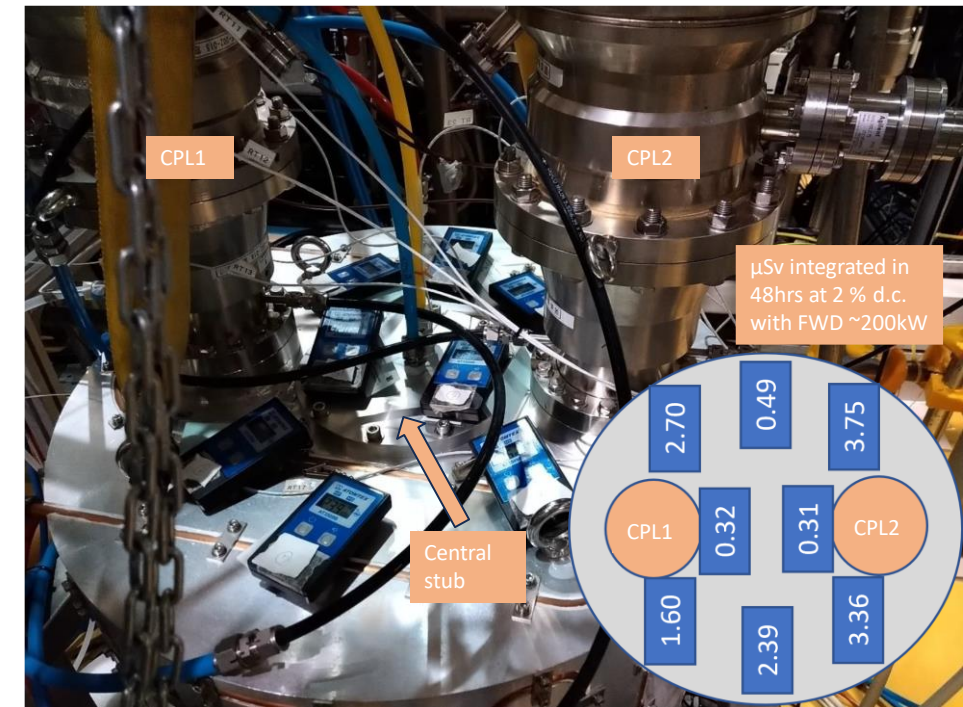
μSv integrated in 48hrs at 2 % d.c. with FWD ~200kW

Integrated dose at d.c. 2% FWD 200kW over 48hrs. Low dose on central stub. → X-ray from gap in cavity (no MP in CPL1)

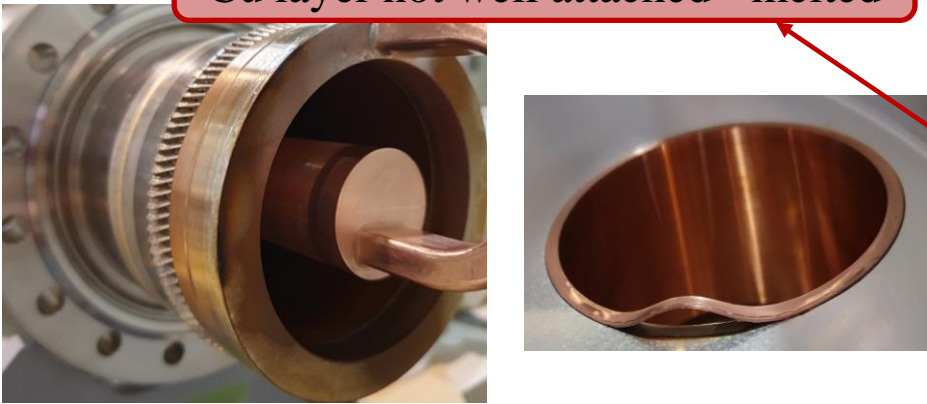
Cu layer not well attached - melted

Cu layer on SUS input flange not well attached, RF enter gap and create loop, which further melt and deform. Heat marks on the nearby coupler are visible.

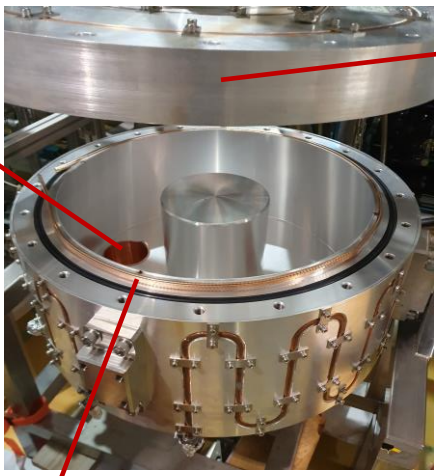
MP / Arcs , protruded and melted RF fingers

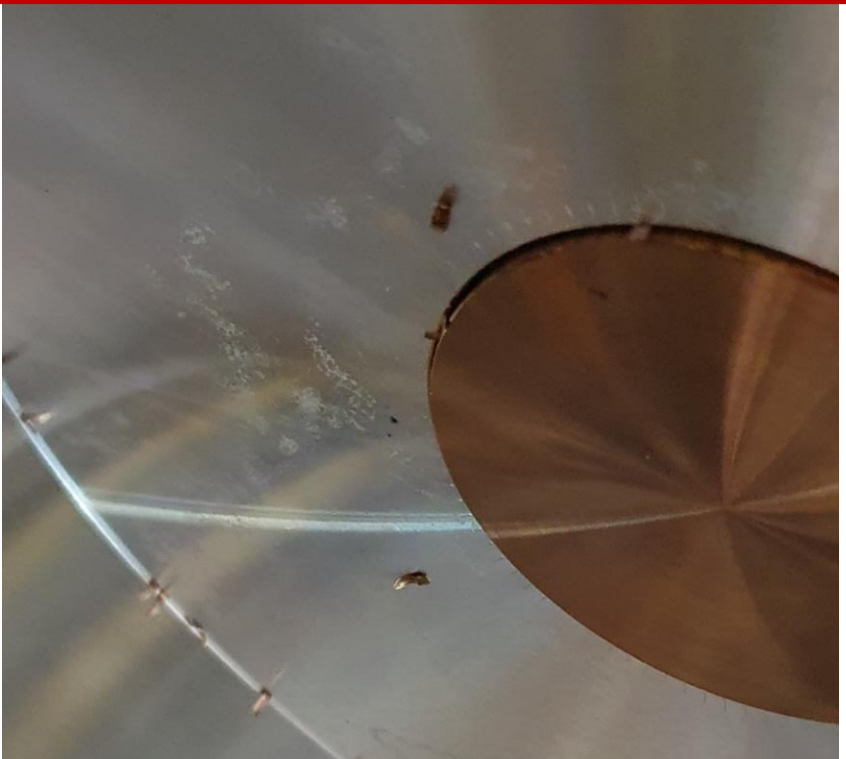
Traces of MP on cavity surface near tuner. Also, visible deformed and melted RF fingers.

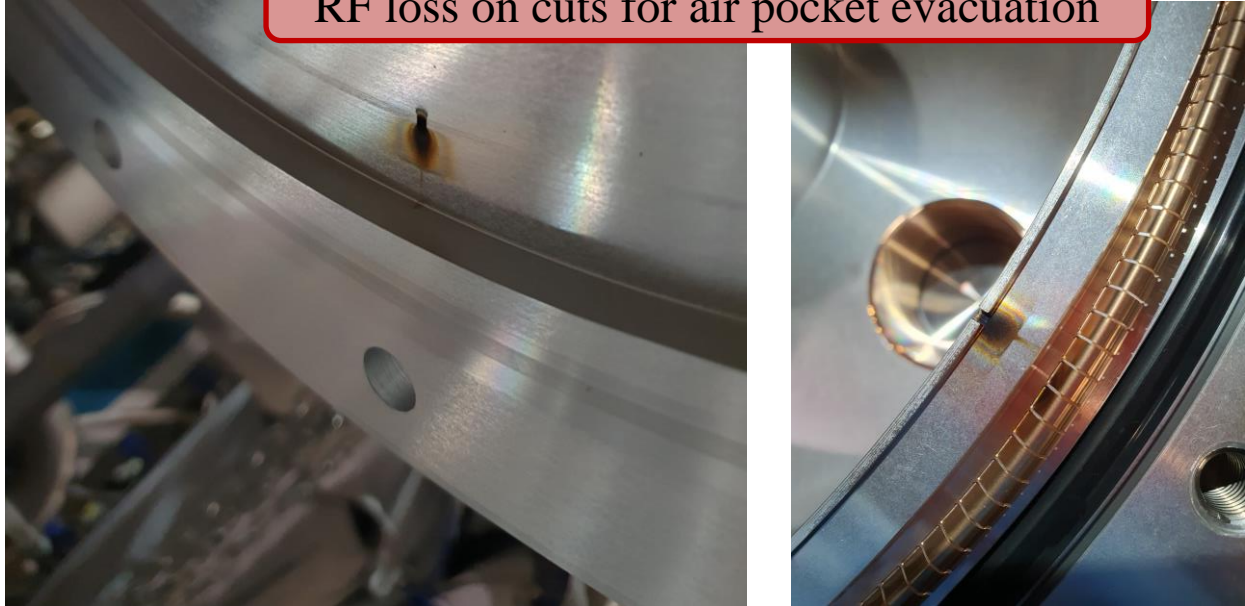
RF loss on cuts for air pocket evacuation

RF loss induced heat in the cuts used for evacuation of air pocket near O-ring.

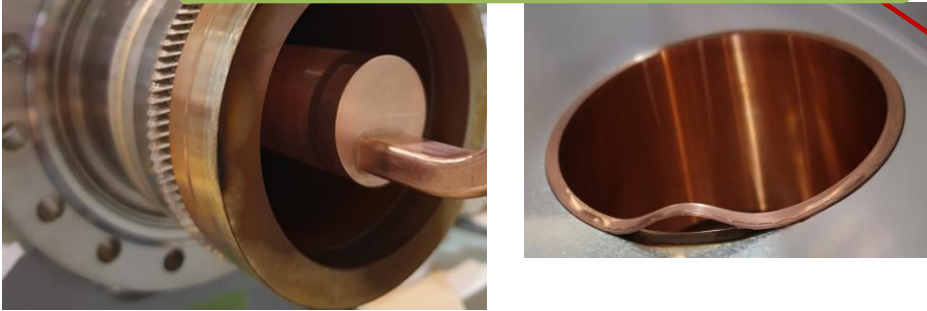
Cu layer not well attached - melted

Cu layer on SUS input flange not well attached, RF enter gap and create loop, which further melt and deform. Heat marks on the nearby coupler are visible.

Replace with Cu plating

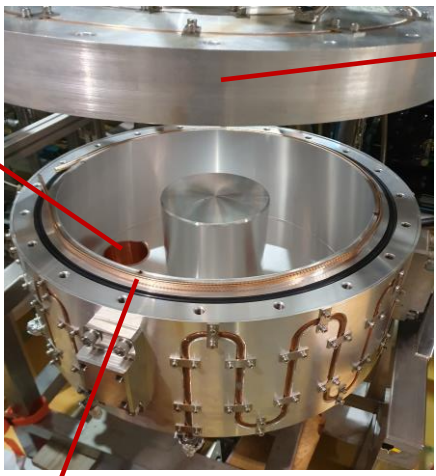
MP / Arcs , protruded and melted RF fingers

Edges/gaps of tuner in high E region not ideal.  
Remove tuner and replace with flat lid.  
Cu plating of entire inner surface.

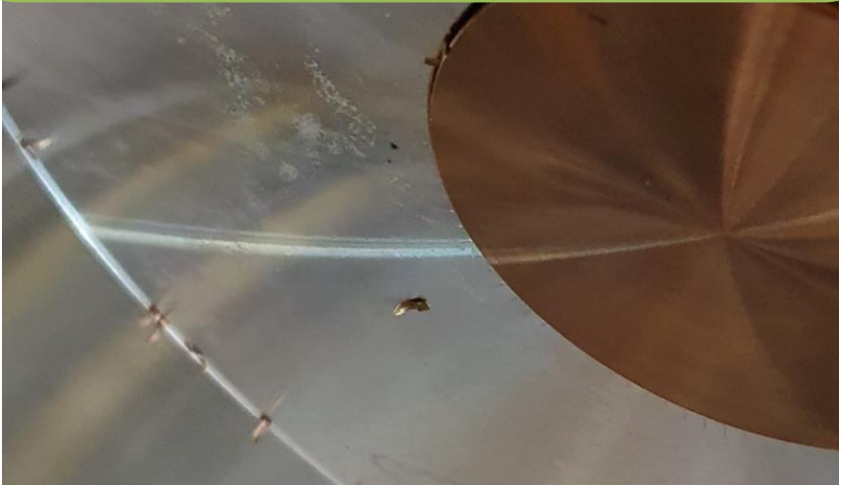
Traces of MP on cavity surface near tuner. Also, visible deformed and melted RF fingers.

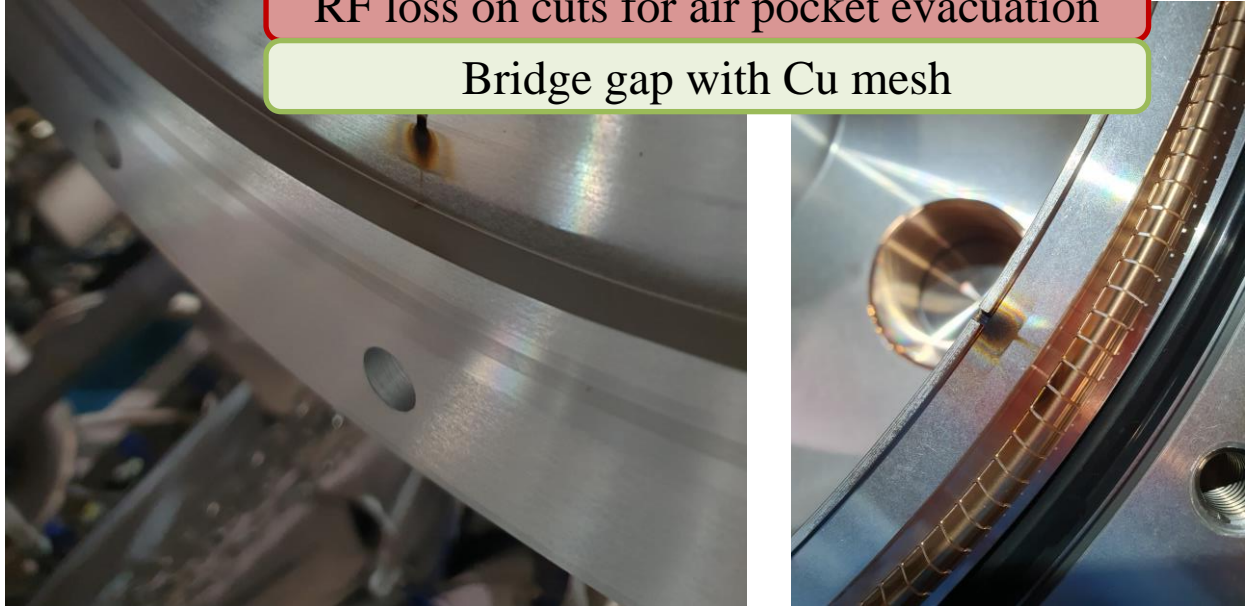
RF loss on cuts for air pocket evacuation

RF loss induced heat in the cuts used for evacuation of air pocket near O-ring.

Bridge gap with Cu mesh
