RADIATION DAMAGES AND CORROSIONS IN TRISTAN VACUUM SYSTEM.

T. Momose, K. Narushima, K. Kanazawa, Y. Suetsugu, H. Hisamatsu, M. Shimamoto, and H. Ishimaru

National Laboratory for High Energy Physics
Oho-machi, Tsukuba-gun, Ibaraki-ken, 305, Japan

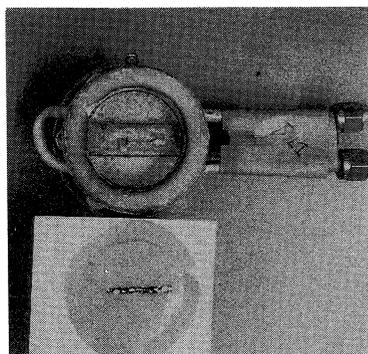
Photo 1 Be window for IT and a Kapton film cover (below).

070 flange on which a beryllium window is electron beam welded is set. A beryllium window was covered by an aluminum cylinder sealed by an aluminum foil ($80 \mu\text{m}$) using epoxy resins. Inside the cylinder, helium gas ($1 \text{ cm}^3/\text{min}$) was introduced to protect the beryllium surface from corrosion. At the first operation of IT, Kapton film was used instead of an aluminum foil. However the Kapton film was burned by several day operation (Photo 1). Since then an aluminum foil has been used. The radiated part of the foil was relatively clean, on the other hand, white powder like material was observed on neighborhood of the radiated part. An aluminum foil covered with bömite film was used to reduce corrosion. But no significant difference was observed compared with an ordinary aluminum foil. This is because the binding energy of the film is very low compared with that of the light. Miscontrol of the helium gas flow caused corrosion of beryllium surface and sealing failure of the vacuum chamber (Photo 1). For further reduction of the beryllium corrosion, inside the cylinder was evacuated by a rotary pump instead using helium gas flowing. By this method protection of a beryllium plate was improved. (Photo 2). The radiated part of the beryllium plate is clean and the place adjacent to the part is covered by black material. The similar was observed inside surface of the aluminum foil (Photo 2). The material can be carbonated oil. One more method to protect the surface is to cover the surface by Vacseal. This is effective to obtain longer life of the beryllium plate.

Epoxy resin to seal aluminum foil changed its color from milky white to brown by the influence of radiation or the produced acids. Similar influence was observed on the Synflex (nylon) tube to supply helium gas. The colored pipe is brittle, therefore Synflex tube can't be used for movable equipments.

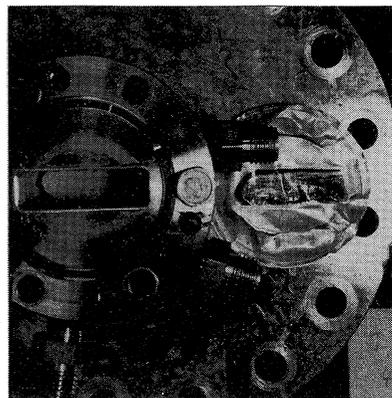
Photo 2 Be window for IT (left) and an Al foil (right).

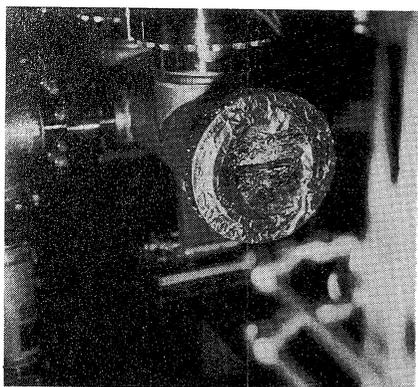
Several aluminum windows are used as beam profile monitors. An aluminum foil (80 μ m) sealed vacuum chamber from atmosphere using a Helicoflex. To protect the aluminum surface a small cylindrical room is made for helium gas flowing (TAR) and for evacuation by a rotary pump (TMR). The room was covered by another aluminum foil using epoxy resins. The surface of the foil was corroded. Similar corrosion was observed on the aluminum foil set in an extracting line (Photo 4, TAR). The line is utilized for medical science using synchrotron light at 5.7GeV beam energy ($\epsilon_c = 18\text{KeV}$). The extracting window is an ICF-152 flange but the thickness is decreased to 2mm. The foil is set on a flange of the beam line and the surface of the foil show some white corroded material.

Photo 4 Al foil set on the beam line for medical science.

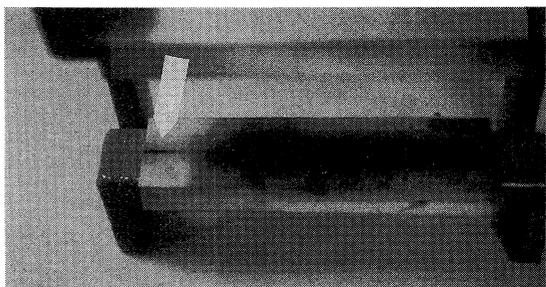
Burning mark was observed on the cover (epoxy) of the coil of kicker magnets for the ceramic chambers (Photo 6). This fact confirms that the one end of several ceramics was not masked from synchrotron light by the aluminum absorbers. Since the length of the burning is several cm, it can be estimated that radiated area inside surface of the ceramics is longer.

Photo 6 Burning of the cover of the coil of a kicker magnet.
