ELECTRIC-DISCHARGE-BREAKDOWN PHENOMENA OF A GLASS WINDOW USED IN A FLUORESCENT SCREEN MONITOR

T. Suwada* and K. Kakahara, *KEK, Tsukuba, Ibaraki, 305-0801 Japan*

Abstract

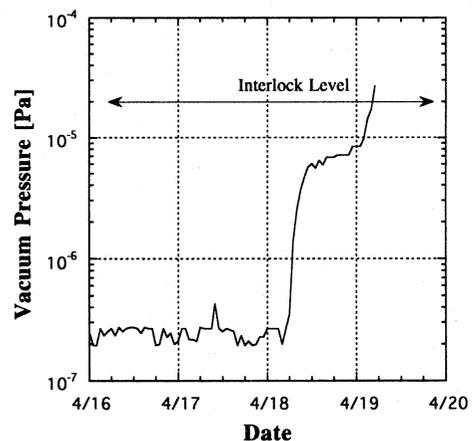
Figure 1 shows the variation of a vacuum pressure measured by an ion pump located at sector 3 during about four days up to the start of the vacuum leakage from the viewing window. The degree of the vacuum started to become worse in 18th in April and, after that, a rapid growth of the degree of the vacuum continued until 19th, and finally the linac operation became impossible due to the interlock-system operation over the vacuum limit. This vacuum leakage was identified from the viewing window of the screen monitor located at sector 3 after an immediate leakage test using a helium detector. After replacing the viewing window by a new one, linac operation was started again without feeding RF power into the accelerator structures.

Figure 1: Variation in a degree of the vacuum in sector 3 measured by an ion pump during about four days up to the start of the vacuum leakage from the viewing window.

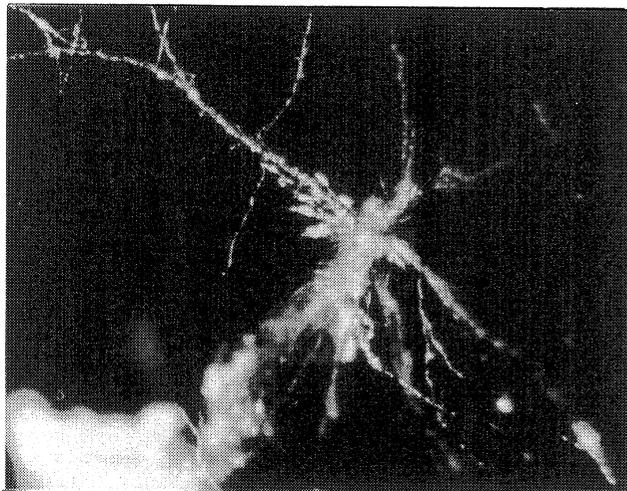
The viewing window used in the screen monitor comprises a silica glass (SiO_2 :68%, B_2O_3 :18%, K_2O :9%, Al_2O_3 :3%, other:2% [wt%]) with a thickness of 4.5 mm and with a diameter of 38 mm based on the ICF70 standard. Figures 2 (a) and (b) show photo pictures of this viewing window broken down due to the electric discharge. Both pictures were taken from the window surface in the vacuum side. Figure 2 (a) shows about twenty main traces with a clear symmetry caused by the electric discharge. Two kinds of the discharge traces are found in the figure. One is a trace group generated from the glass centre; it grows in the direction of the inner side of the metal flange with many fine branch traces. The other trace group is also generated with many fine branch traces from the inner corner of the metal flange; it grows in the direction of the glass centre. Figure 2 (b) shows a microscopic picture of the breakdown point penetrating the window glass in which a thick main trace is seen at the centre of the picture. It was located about 11mm apart from the glass centre. We found only one discharge trace penetrating the window, which caused the vacuum leakage. This penetrating trace is not a straight line, but a loosely curved line. The thickness of the penetrating trace is barely observable by human eye and it is around a few hundred μm . We can also find several narrow discharge traces developing transversely from the main discharge point to the metal flange; they also have several narrow branch traces. No transverse traces were found on the atmospheric surface side of the window glass.

At present, we understand that such high-intensity dark currents might cause a high radiation environment at this screen monitor and, especially, low-energy electromagnetic radiations might hit the window surface synchronously with a RF pulse having a repetition rate of 50 Hz. It is thus expected that a large amount of soft (relatively low-energy) electromagnetic radiation accumulated on the window surface, which caused electric-discharge breakdown.

Figure 2: (a) Digital (top) and (b) microscopic photo (bottom) pictures of the generated electric-discharge traces on the glass surface of the viewing window.

For the reason described in the previous section, we found a cure by using a new viewing window with electrical conductivity on its surface in order not to accumulate electrical charge. The new viewing window

comprises the same silica glass coated with a thin film of stannic oxide (SnO₂). The thin film was spread out on the window surface by a spray and was fixed by a high-temperature process. The electric resistance between the glass and the metal flange was measured to be about 950 Ω. The new viewing windows will be replaced at three locations under a high-radiation environment during the summer shutdown.

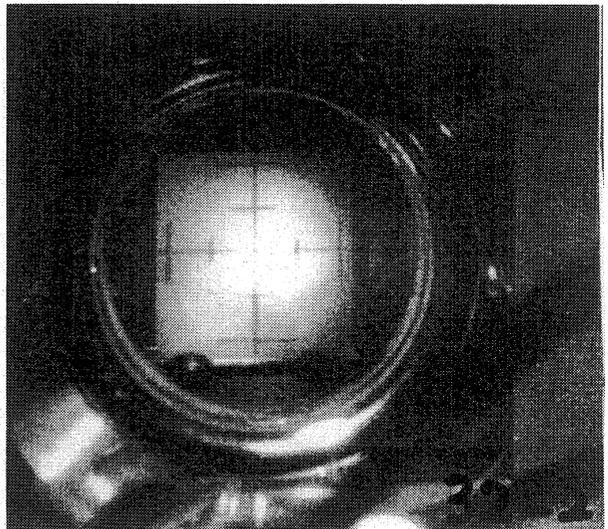
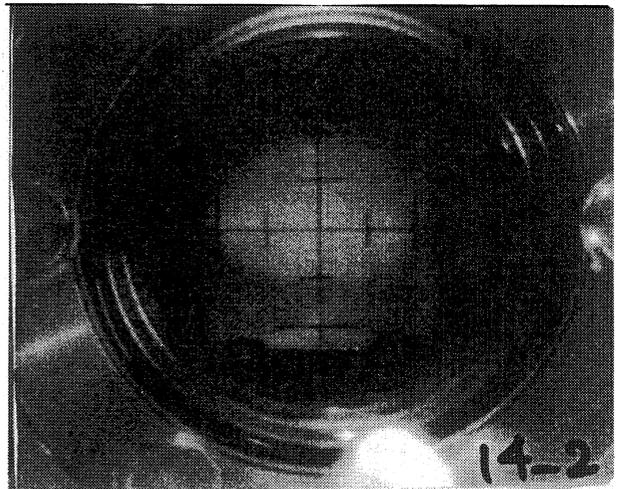
Next, we checked the dark currents generated from the accelerator structures, which also could cause a high-radiation environment at the monitor position. The radiation environment on the linac beam line is expected to be higher than that before the KEKB project started because the pulsed RF power from a high-power klystron was boosted to be nearly double and the acceleration gradient was also boosted to be 20 MV/m from ~7 MV/m by using a pulse-compression device. Figure 4 shows the arrangement of the accelerator structures around the screen monitor on the beam line. As can be seen from the figure, it is expected to easily generate a high radiation environment due to the dark currents at the monitor position located only 270 mm from an output coupler of the upstream accelerator structure. Figure 5 shows typical fluorescent images (a) for this monitor and (b) for another typical monitor under the typical operational condition without beams. The fluorescent intensity for the former screen is clearly stronger than that for the latter screen.

Figure 5: Typical photo pictures of the fluorescent screen images generated by dark currents from the accelerator structures, (a) the screen image (top) of the monitor accompanying by the vacuum breakdown and (b) the screen image (bottom) of another typical monitor.
