INSTABILITIES DUE TO MULTIPACTORING, MODULATION AND ANODE EMISSION FOUND FOR TRISTAN HIGH POWER CW KLYSTRONS

M. Yoshida, S. Isagawa, Yo .Takeuchi, M. Ono, M. Sato, K. Takata and H .Baba
National Laboratory for high Energy Physics (KEK) Oho-machi, Tsukuba-gun, Ibaraki-ken 305, Japan

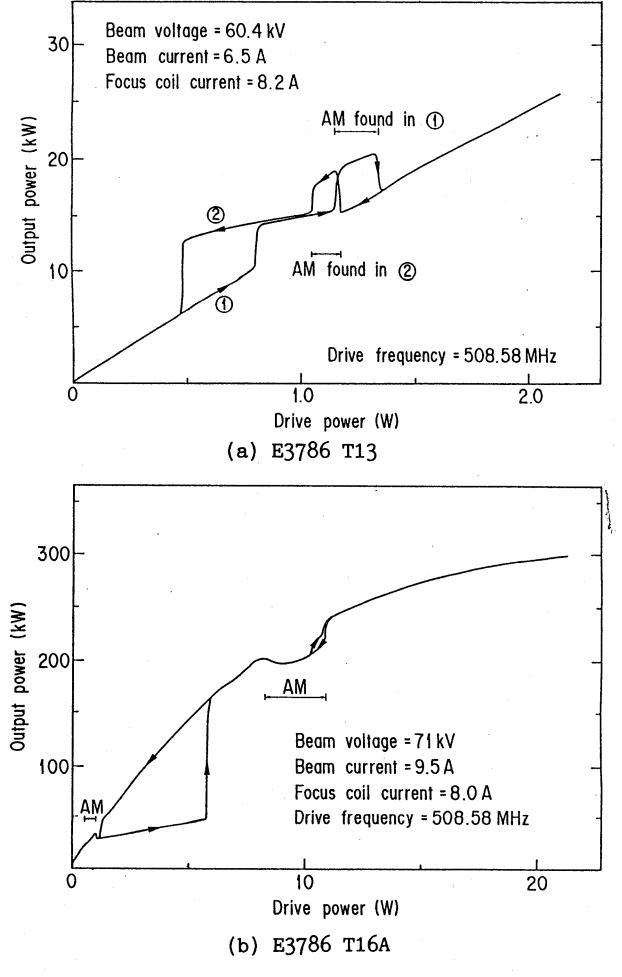
The phenomena of hysteresis and AM are shown in Fig. 1 and Fig. 2. AM in lower part always appears in the same drive and output power levels under the same conditions. In T13 it occurs at output power of 25-35kW on condition that beam voltage (Vk) is 70kV, beam current (Ib) is 9.8A and focus coil current (If) is 8.0A. On the other hand, in T16A, it occurs at both 30-35kW and 200-220kW levels on condition of Vk=70kV, Ib=9.5A, and If=8.0A. Upper AM at 200-220kW disappeared after high power aging at RF power 800kW.

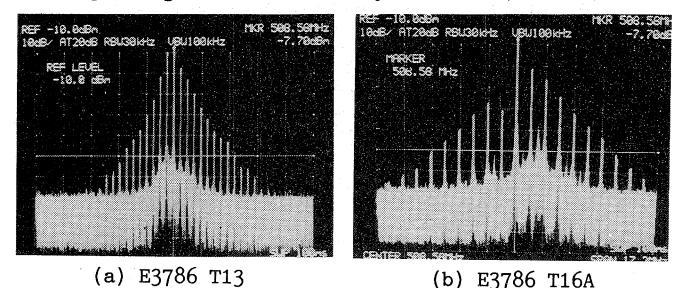
Fig. 2 Amplitude modulation of klystron as seen on spectrum analyzer, (a) span=20MHz (Vk= 60.9kV, Ib=6.8A, If=8.0A, $f_0=508.58MHz$), (b) span=17.3MHz (Vk=73.3kV, Ib=9.7A, If=7.0A, $f_0=508.58MHz$).

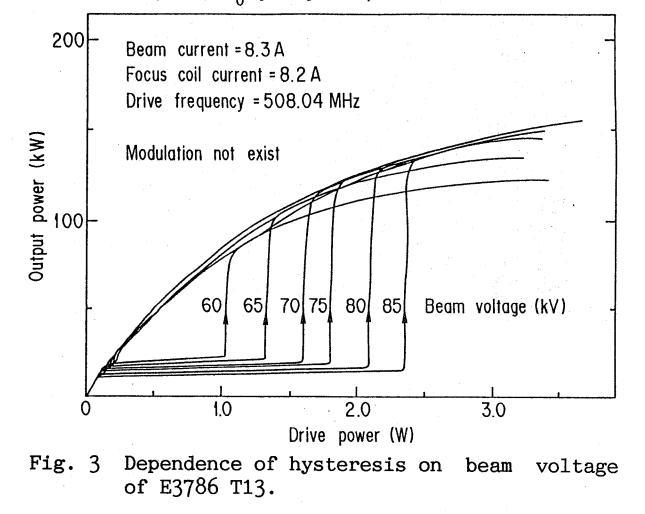
Dependence of the power of T13 on the beam and anode voltage (beam current) is shown in Fig. 3 and Fig. 4, respectively. In these figures, drive frequency(f_0) is varied from 508.04MHz to 508.58MHz. There is no AM but only hysteresis at 508.04MHz which is a resonant frequency of the 2nd cavity of T13. At 508.58MHz, AM occurs at the beginning of hysteresis. Two figures indicate that the power levels above which hysteresis begin almost depend on the anode voltage.

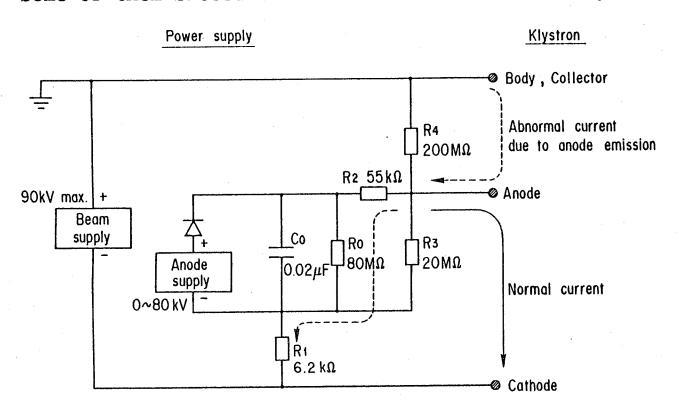
The anode current decreased to negative value on hot days when the max. room temperature in a klystron gallery was 40 °C. Fig. 6 illustrate the mechanisum of beam overcurrent. Normally the anode current flows from anode to Wehnelt which is in cathode potential. In this abnormal case, however, the current flows from body to anode and into R_0 , R_1 and R_2 . More current flows as the anode voltage, that is, the beam current grows. As a result of positive feedback, anode voltage power supply falls into uncontrolable state and interrupts the system. These behaviors are shown in Fig. 7. The anode current decreases to negative value very slowly.

Fig. 6 Schematic circuit of klystron power supply.

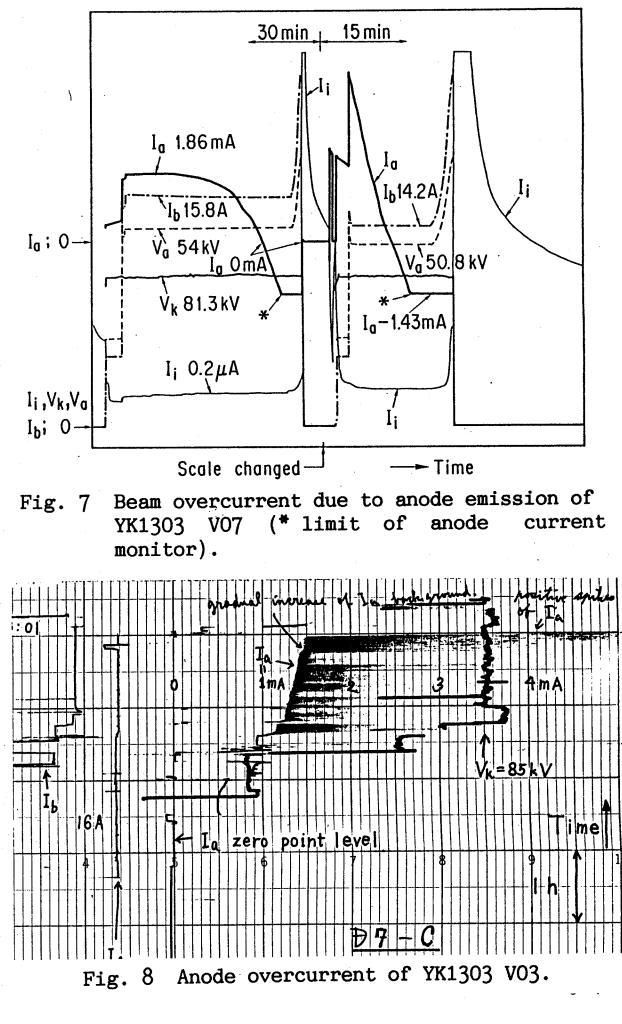
The positive spikes of anode current are shown in Fig. 8. Rise time of these spikes are about 20msec. Although most of their heights are smaller than 3mA, some of them exceed the interlock level of totally 7mA.

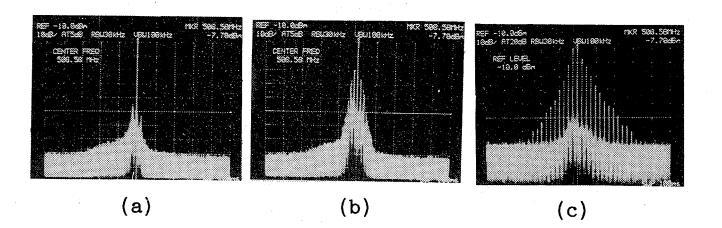
If the surface of 2nd cavity gap could be changed, multipactoring would be suppressed. We tried to change the surface by hitting parts of electron beam to the cavity gap. After 63 hour's hit under the conditions of the focus coil current 2.5-3.0A and DC input power 47kW, both AM and hysteresis in T13 incidentally disappeared. However, a little later, the modulation gradually reappeared as shown in Fig. 9. But this hitting have surely an effect on AM and hysterisis. In fact, there is no AM and hysteresis now for the focus coil current of 7.0A and 8.0A and the anode voltage of 30kV and 40kV, respectively. The smaller focus coil current and the larger anode voltage seem to be better to expel both AM and hysteresis.

Fig. 9 Amplitude Modulation as seen on spectrum analyzer after 63 hours aging of E3786 T13 span=20MHz (Vk=60.1kV, Ib=6.7A, If= 8.0A, f₀=508.58MHz). (a) 30 seconds later, (b) 2 minutes later, (c) 20 minutes later.
