## Core buckling position measurement for J-PARC RCS cavity

An impedance reduction had been detected in the J-PARC RCS cavity 7 in January 2009. After taking out and opening the cavity tanks, buckling at the inner radius was detected at some of the MA cores. Here we describe the development and application of magnetic sensors, which were expected to detect the buckling of the cores in the stainless steel water tanks without the need for taking out and opening them.

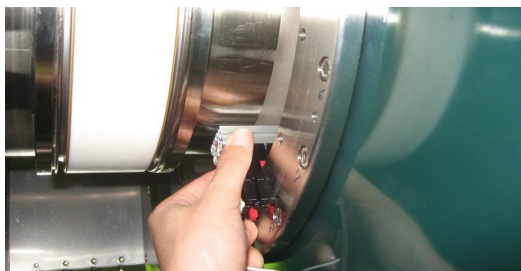
Figure 1: Finemet yoke sensor inserted between beam pipe and cavity tank for buckling check.

Taking out from the tunnel and later re-installing a cavity means breaking the vacuum. Such process including alignment takes in the order of 2-3 weeks. From experience with cavity 7, a significant tank impedance change might indicate core buckling. However, a core with modest buckling might not lead to impedance change. Therefore we try to detect core buckling in installed cavities without taking out and opening the water tanks. We developed inductive sensors, which are put between beam pipe and inner cylinder of the cavity tank under test as shown in fig. 1.

The angle and longitudinal position of the sensor are varied to obtain a map of the magnetic permeability environment. The inductance measurement frequency is chosen low enough, in the order of 100 Hz, resulting in a

skin depth of 42.7 mm, so that the magnetic field generated by the sensor can go through the 5 mm thick stainless steel and interact with the MA cores in the tank. Buckling is equivalent to a geometry change in the permeability environment, and the sensor is expected to detect this.

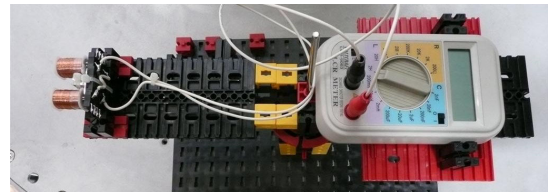
Figure 8: Buckling detection test with relay sensor.

A comparable sensor was made by combining 2 yokes and coils from 24 V relays and tried in the buckling test setup, shown in fig. 8. The radar plot is in Fig. 9.
