# High power continuous wave test of RF couplers for the RFQ of the Linear IFMIF Prototype Accelerator.

DE FRANCO Andrea for the LIPAc team

第20回日本加速器学会年会 - 29<sup>th</sup> August – 1<sup>st</sup> September 2023

Linear IFMIF Prototype Accelerator (LIPAc)

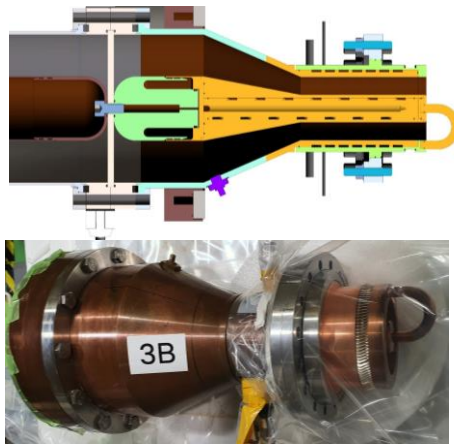
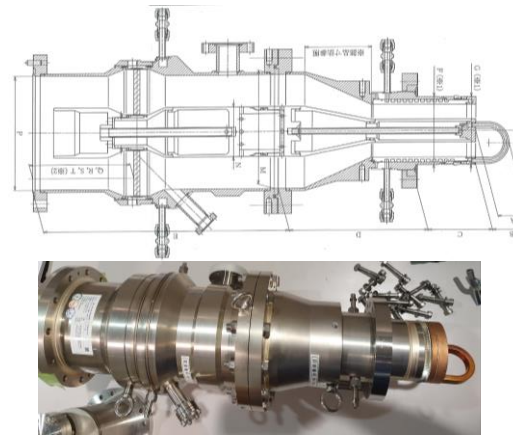
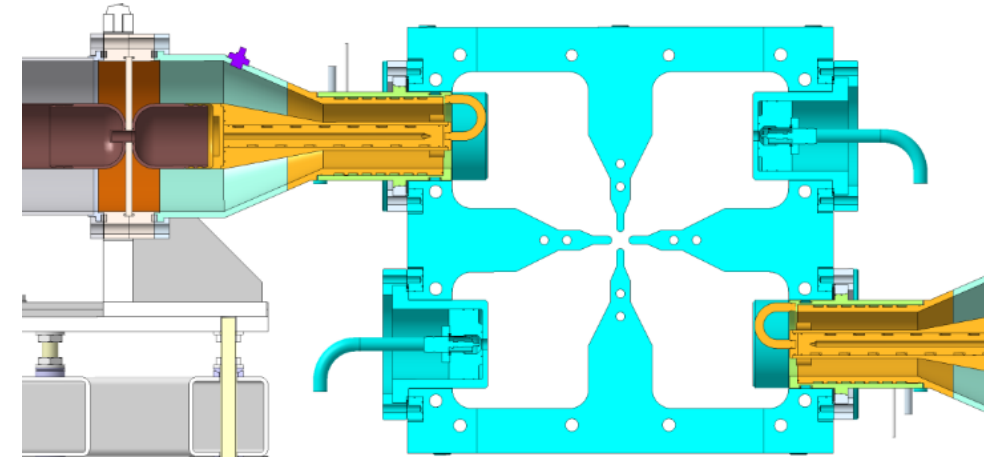
2D cut view of RFQ and its O-ring couplers before cooling enhancement.

O-ring couplers damaged during RF conditioning at high duty cycle.

Improved heat extraction design and re-installed in RFQ.

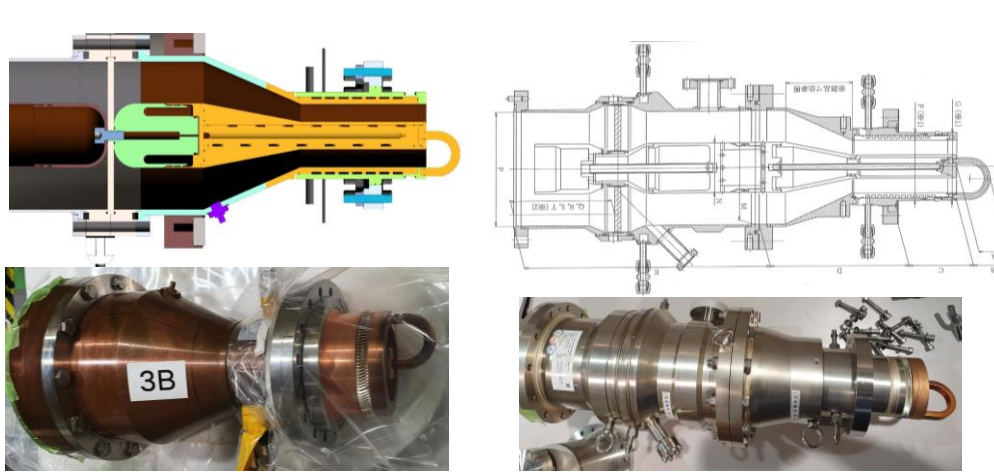
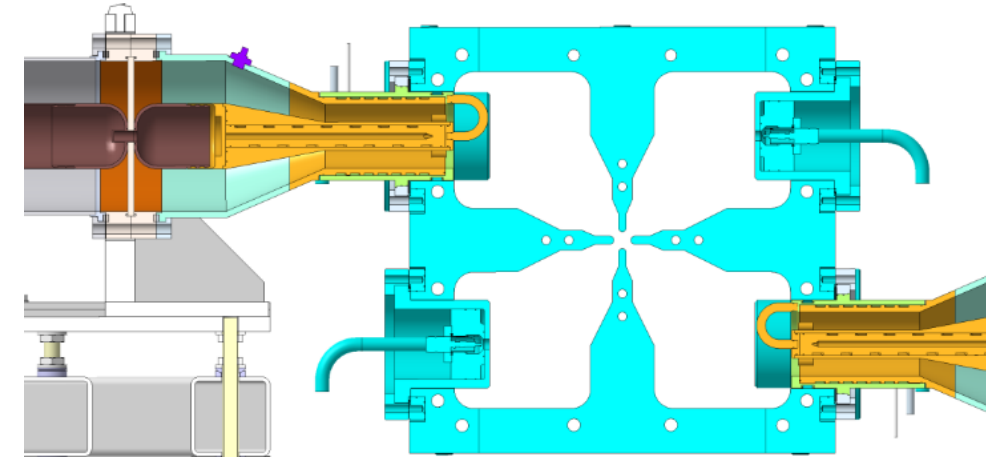
2D cut view of RFQ and its O-ring couplers before cooling enhancement.

O-ring couplers damaged during RF conditioning at high duty cycle.

Improved heat extraction design and re-installed in RFQ.

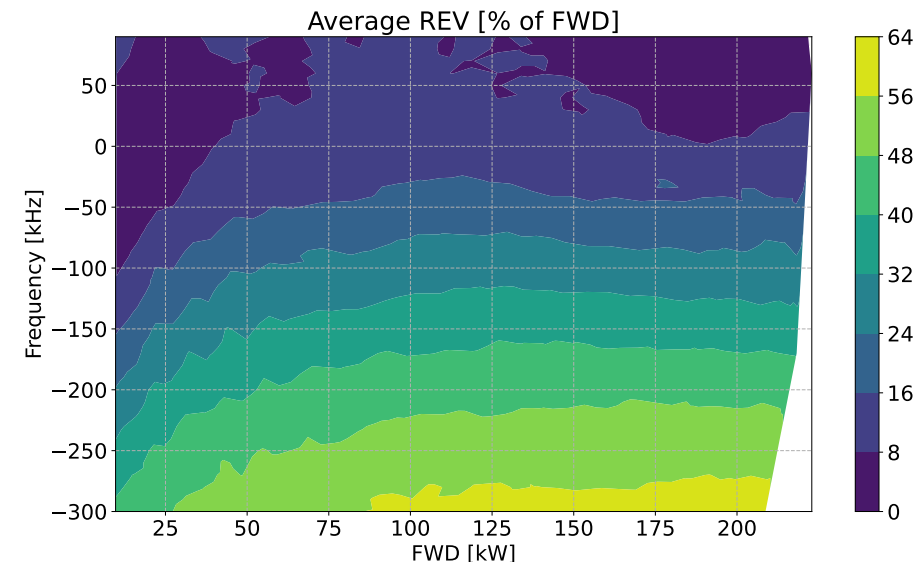
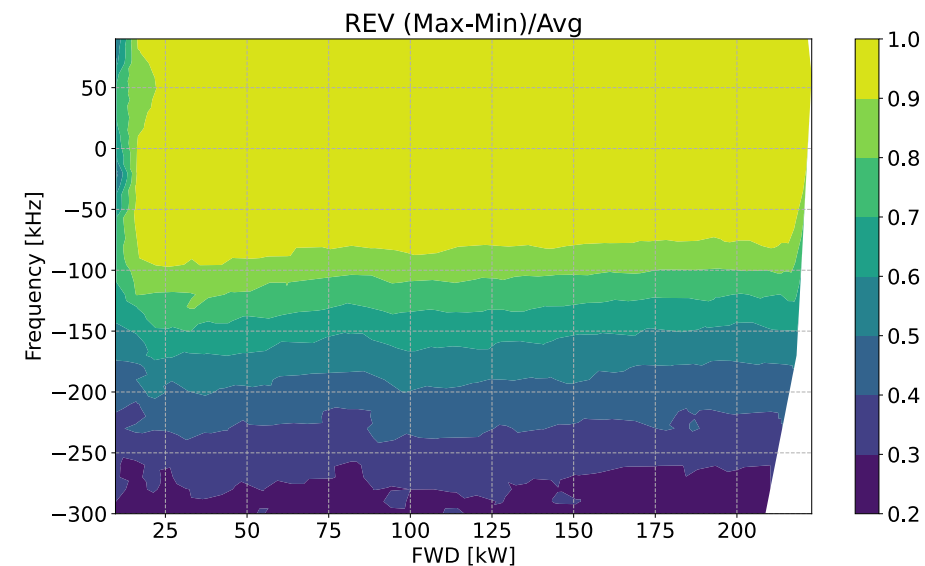
2D scan of FWD and its frequency. No overlap with flat and small on average REV.

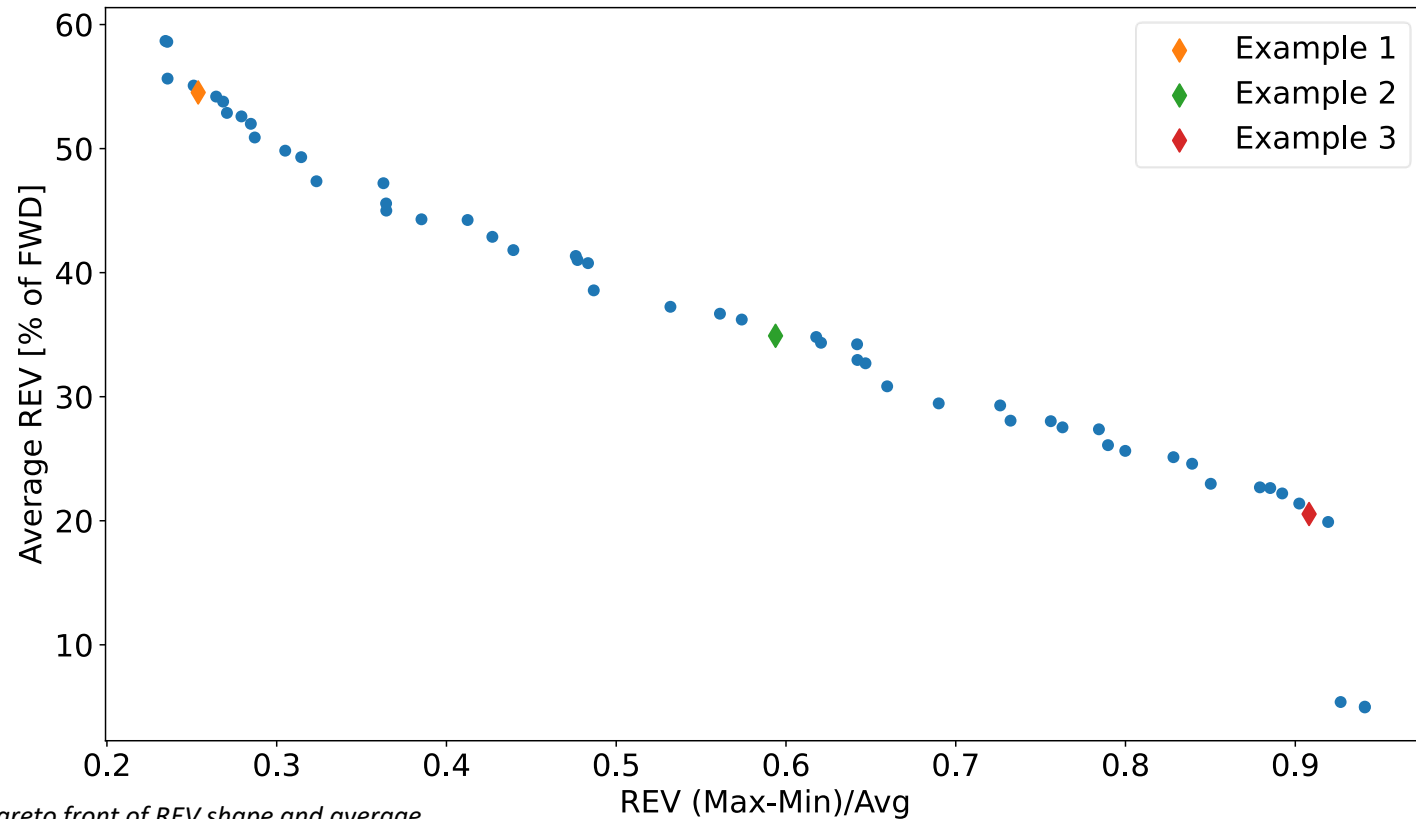
Pareto front of REV shape and average.

Multipacting is present in any combination of FWD/frequency the system is capable to operate at. End of the test?

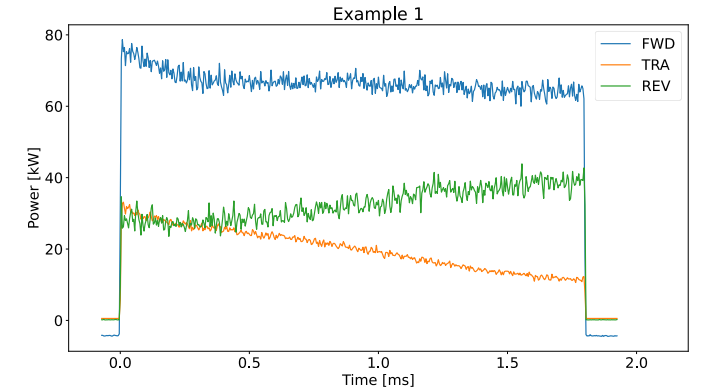
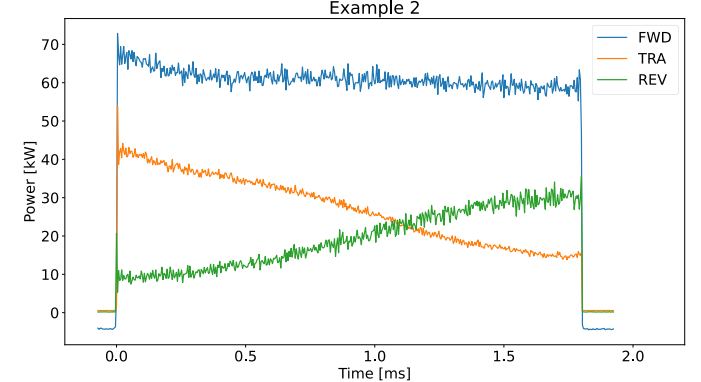
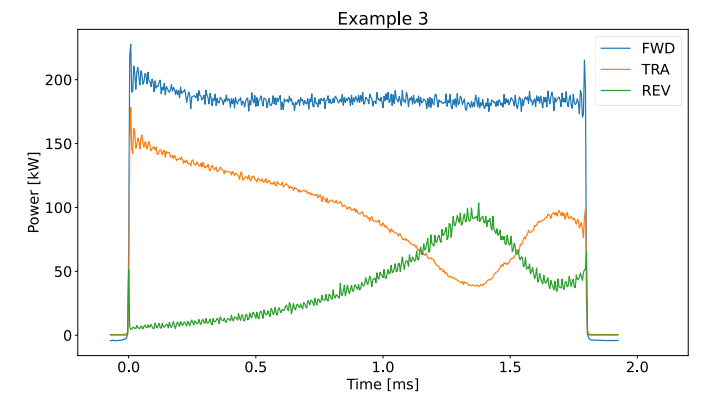
Example pulse shapes along the Pareto front of REV shape and average.

TRA too low to conclude on CPL2  
 CPL1 in much stricter conditions than originally intended.  
 → sufficient for design validation!
