ELECTRIC-DISCHARGE-BREAKDOWN PHENOMENA OF A GLASS WINDOW USED IN A FLUORESCENT SCREEN MONITOR

T. Suwada* and K. Kakahara, *KEK, Tsukuba, Ibaraki, 305-0801 Japan*

Abstract

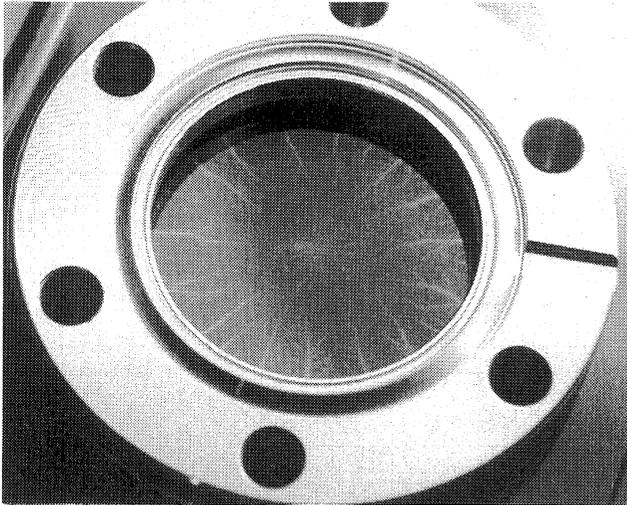
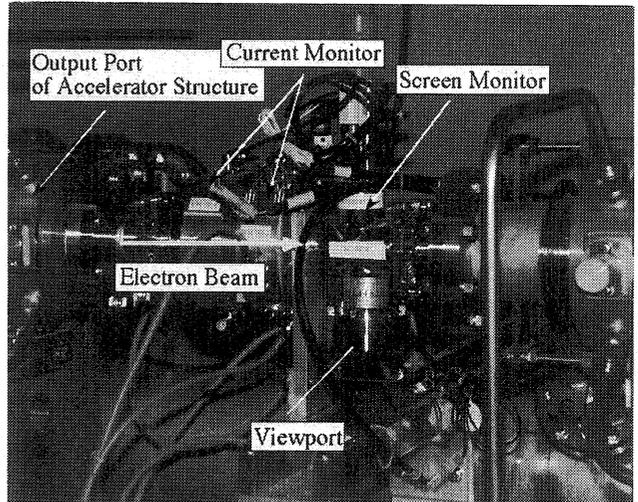
A mechanical drawing of the screen monitor is shown in Fig. 3 and a typical device arrangement around the screen monitor is shown in Fig. 4. The driving system of the screen monitors used in the injector linac is almost the same as that used in other linac facilities. The driving operation of a fluorescent screen is performed by a pneumatic cylinder controlled by compressed air with a pressure of about 5 kgf/cm² using an electromagnetic valve. The initial position of the screen is set to be parallel and 13 mm above to the beam line. The screen is driven at an angle 45 degrees to the beam line by an operator's request. Fluorescent light is sent down through a viewing window mounted 65 mm below from the beam line, and is guided to a CCD camera installed at the floor level by using two aluminium-coated optical mirrors. During the first investigation we had some doubt concerning a bad mechanical drive of the monitor, and thus inferred the generation of a high-radiation environment from the screen due to a beam loss. This inference was immediately rejected after testing the mechanical system both in local control and under remote control.

Figure 4: Arrangement for the screen monitor and its peripheral devices. The screen monitor is installed between two 2m-accelerator structures.

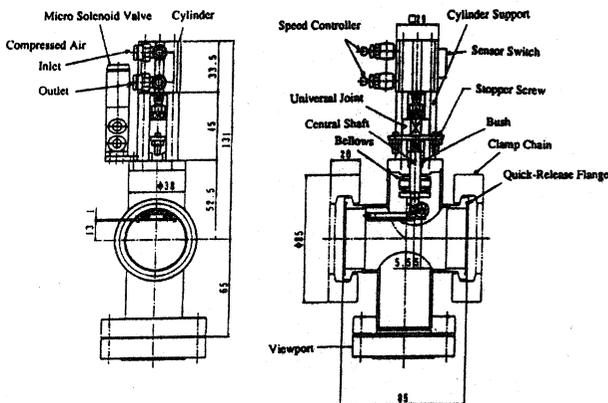
Figure 3: Mechanical drawing of the screen monitor. The beam goes through the monitor from the reverse side to the front in the left drawing, and from the right side to the in the right drawing.
